HARDIMAN I ARM TEST

HARDIMAN I PROTOTYPE PROJECT

Specialty Materials Handling Products Operation  
General Electric Company  
Schenectady, New York 12305

December 31, 1969

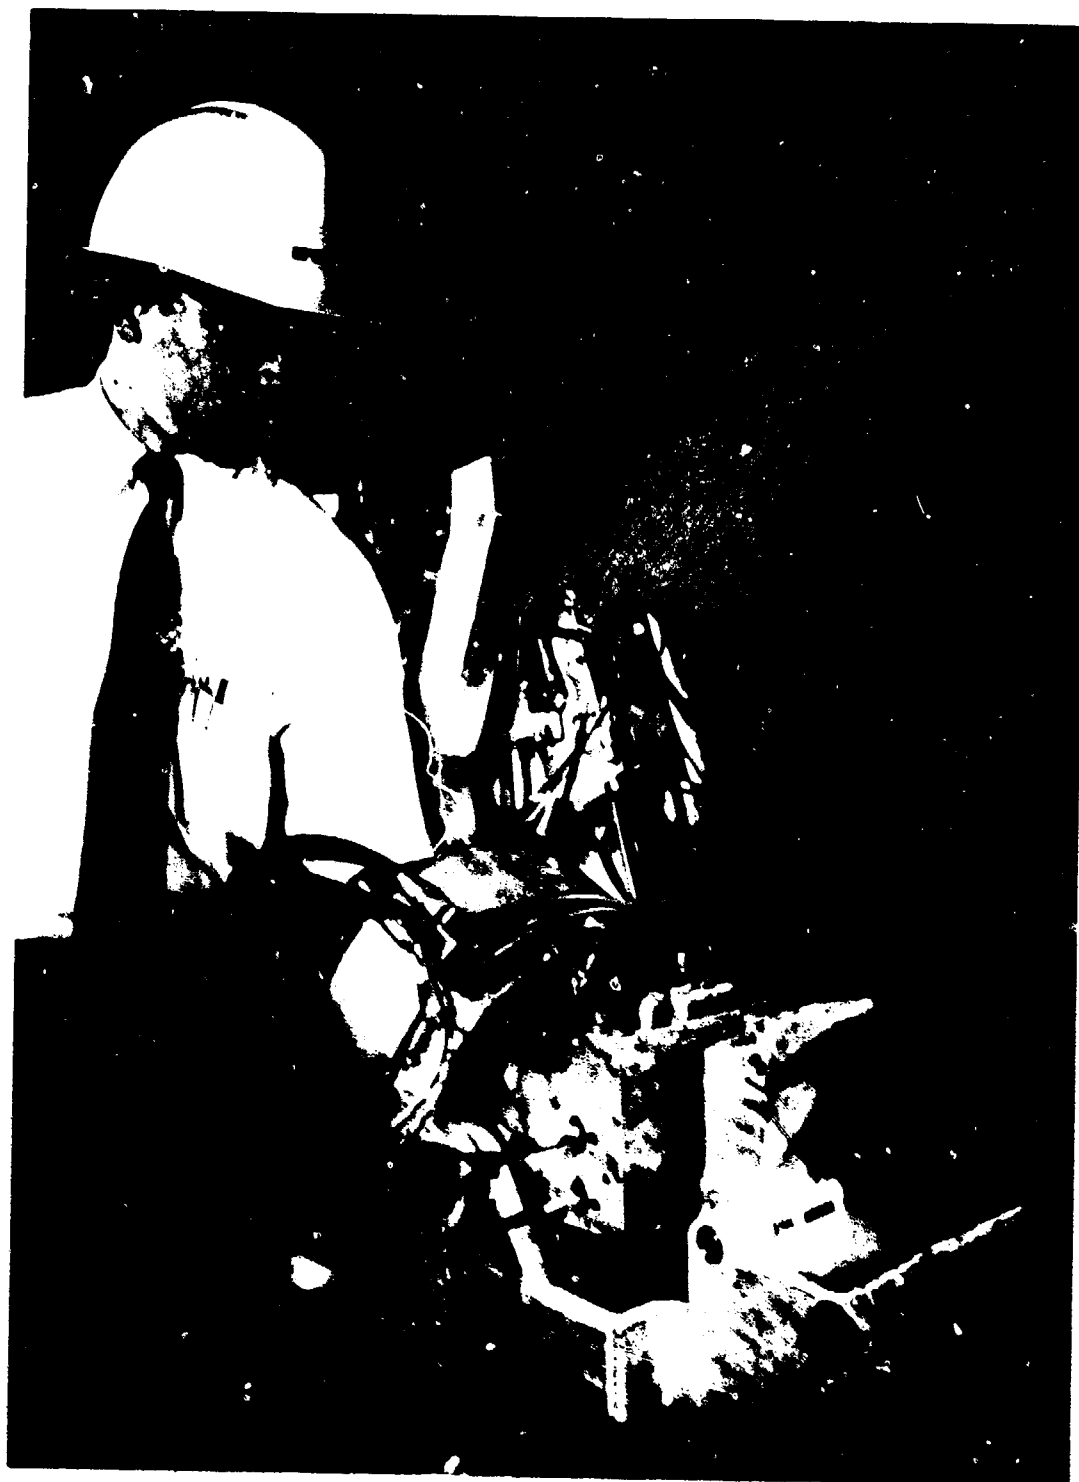
Figure 1. Harbinian I Arm System.

The Hardiman I arm system, Figure 1, is a master-slave system containing eight powered joints. Six of the joints are bilateral servo controlled. These joints are: wrist flex, forearm rotate, elbow flex, upper arm rotate, shoulder flex, and back flex. The thumb tip and thumb flex joints are rate controlled utilizing a velocity valve.

The operator makes contact with the master structure at three points -- the hand, the wrist, and the upper forearm. These latter two contact points are required because the six joints form an unconstrained system. That is to say, the operator cannot define the articulation of the master with only one input.

When the operator places the master in a particular configuration, the desynchronization error between the master and slave is measured at each joint by a tickler mechanism. These errors are converted to electrical signals by transducers and then conditioned and amplified by electronic amplifiers. These signals are then transmitted to appropriate electrohydraulic servo valves which produce differential pressure proportional to the electrical signal. This pressure is applied to the slave actuator for the corresponding joint and causes the joint to move in the same direction as the master. The slave continues to move until the desynchronization error is reduced to a level that will maintain the system in equilibrium. The differential pressure is also applied to the force feedback actuator at each joint. These actuators are designed so that the operator will feel a force, 1/10th of that applied to the slave and in the same directional sense.

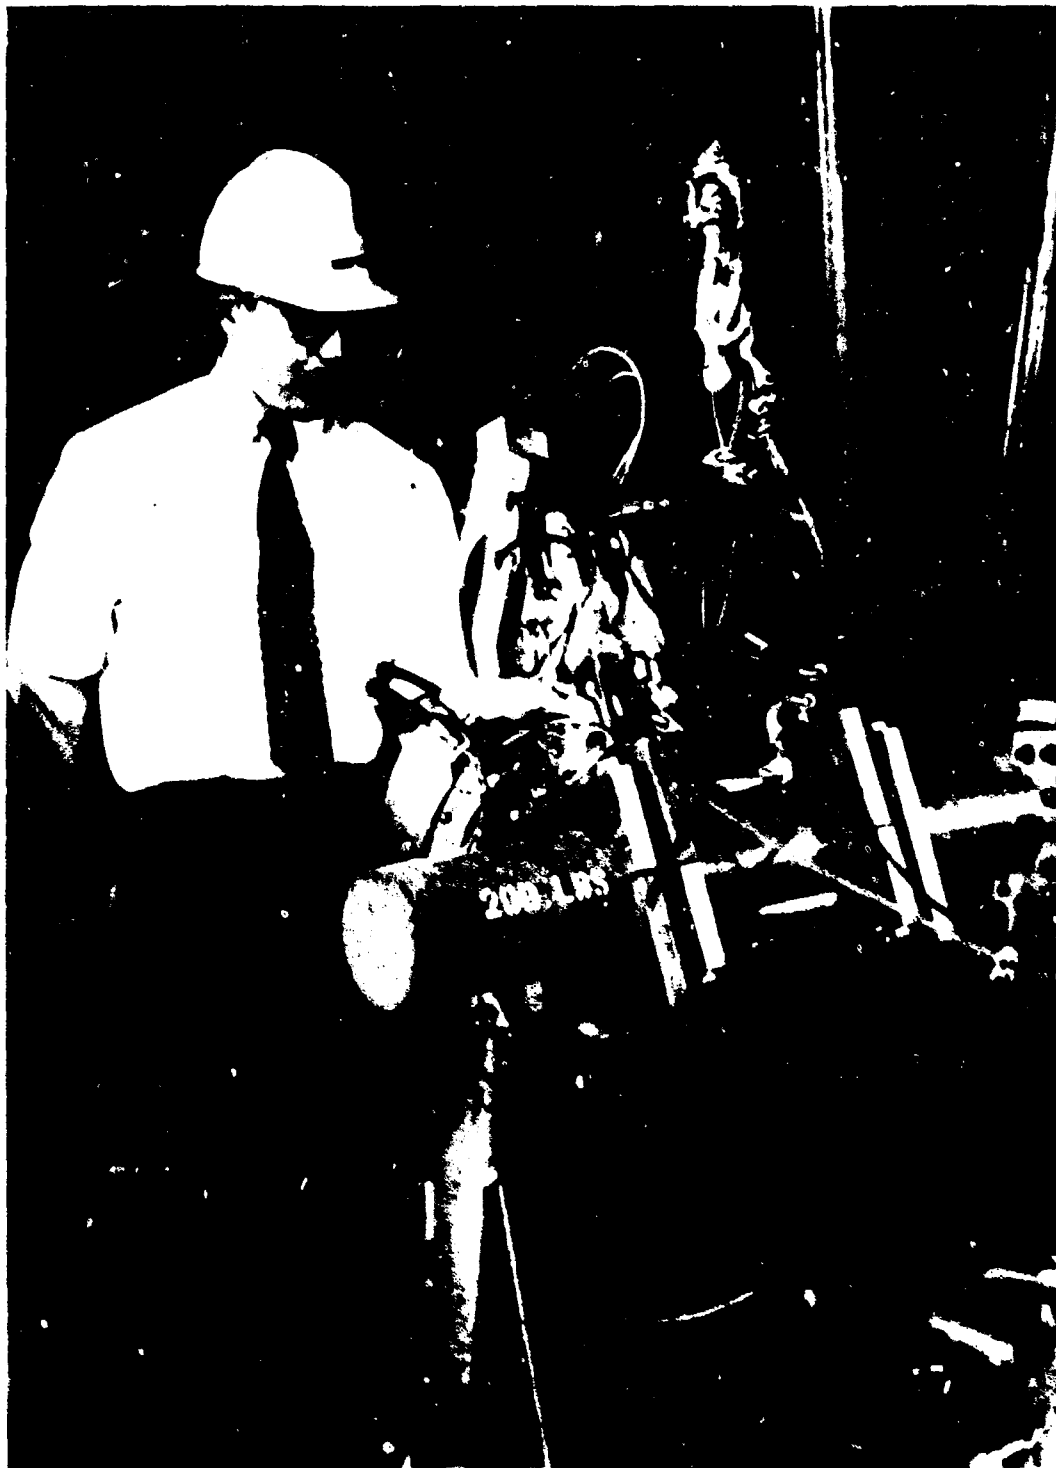
Figure 9. Arm System Lifting 250 Pounds

Figure 9 shows the arm system lifting the 200 pound weight plus 50 pounds of rigging. The frame work in the background is used to support a hoist which acts as a tether and also handles the weights. The operator is wearing the hard hat as normal operating procedure when overhead equipment is being used.

The weight was raised to a height of six feet and in general was handled easily. The operator was able to hold the weight for a period of about one and one half minutes. This was limited because the operator was bending over and reaching out when lifting the weight and therefore exerted a great deal of energy. When the leg system is added, much of this will be eliminated as the legs will do most of the lifting, and the operator will be able to keep the weight in closer to his body.

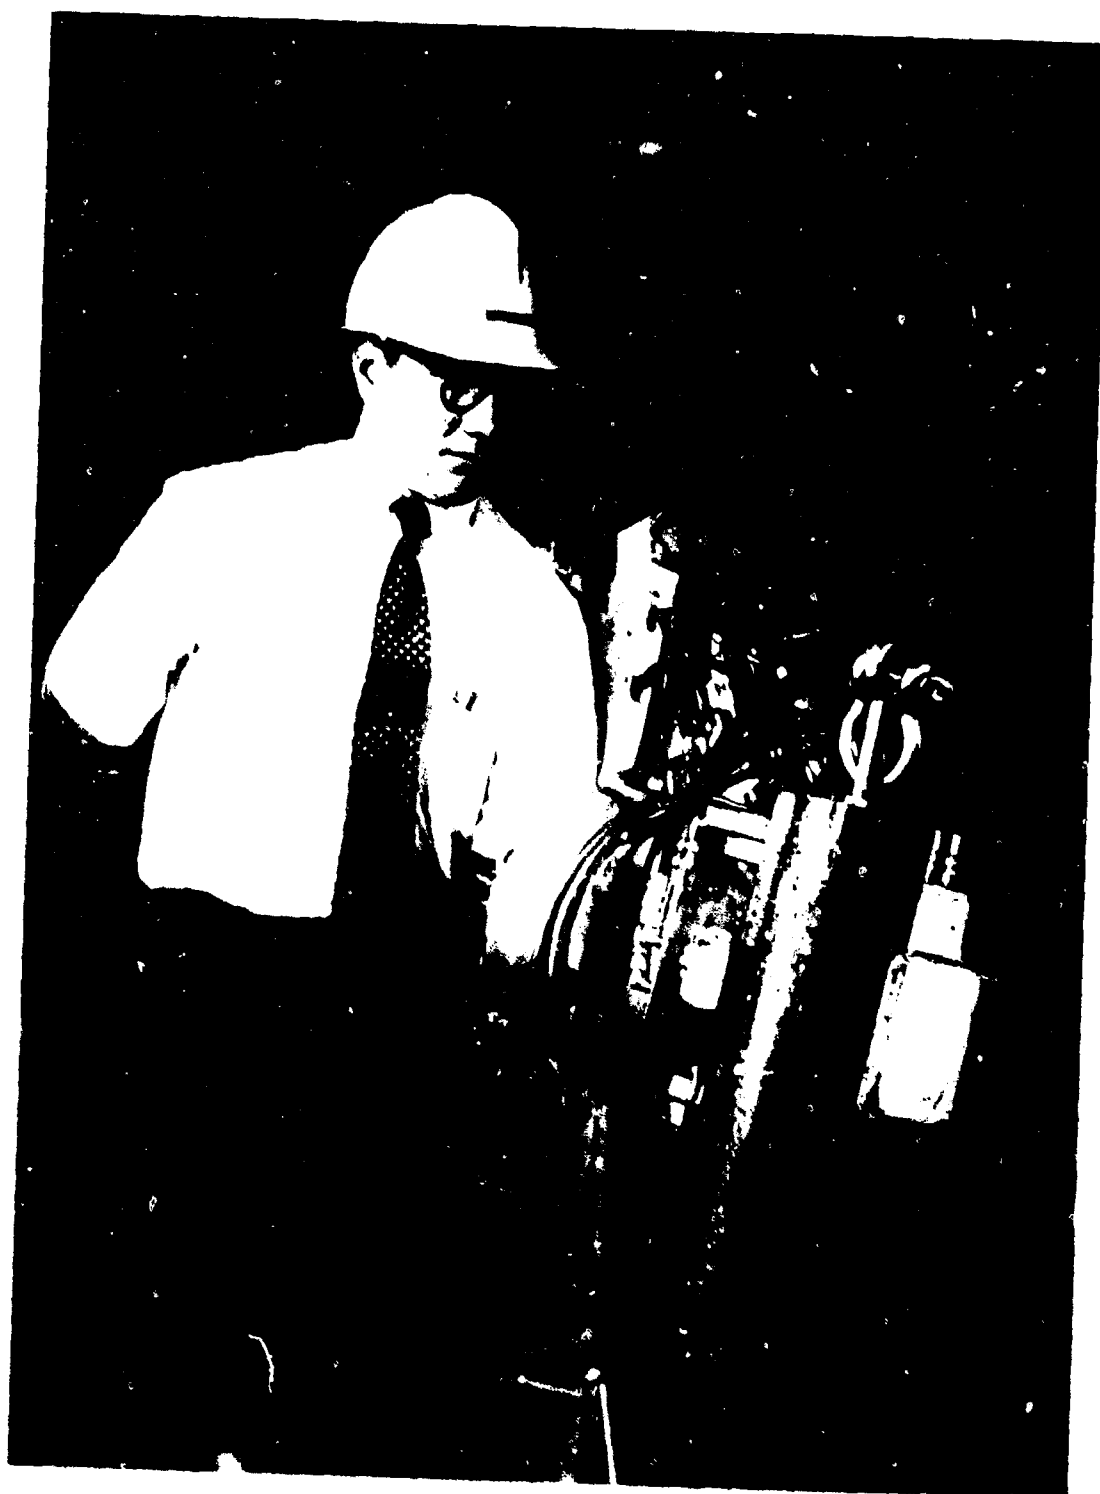
Figure 11. Lifting 100 Pounds Untethered

In Figure 11, the machine is shown lifting the 100 pound weight without the tether. In this position, the gripping force of the thumb is strong enough to support the load. During this test, the weight was removed from a hook, held in the vertical position, rotated 90° to a horizontal position, rotated again to the vertical position, and then placed in a circular tube.
